Pentium® II Processor Specification Update

Release Date: August 1999

Order Number: 243337-029

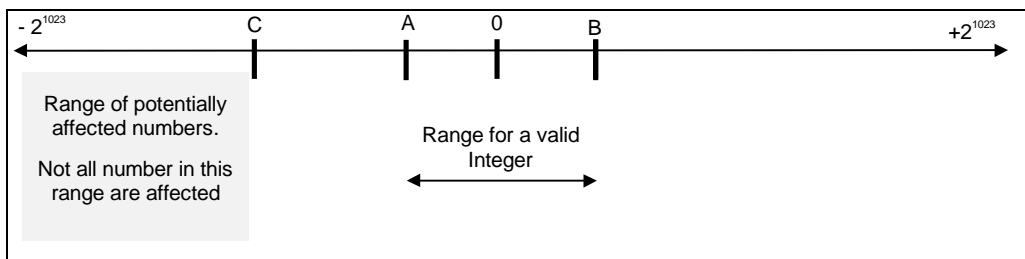
IMPLICATION: Erroneous operation results when the operand is so large that it will not fit into the target data size. The operands affected by this erratum are significantly outside (by a factor of 3X) the range that can be, correctly, converted to an integer value. The figure below and corresponding table identifies the normal range of integer numbers (between A and B) and the starting point of the operands affected by this erratum. Discrete failing operands will be present in the range between point C and the maximum negative number that can be represented by the processor (-2^{1023} in double precision format). Note 2 below gives a qualitative description of the nature of the discrete failing values. Software that does not rely on the Invalid Operation exception flag being set and signaled by either an exception OR by software polling is not impacted by this erratum.

16-bit Operation	A	B	C
	-32,768.0	+32,767.0	< -98304.0
32-bit Operation	A	B	C
	-2,147,483,648.0	+2,147,483,647.0	< -6,442,450,944.0

WORKAROUND: Any of two software workarounds will avoid occurrence of this erratum:

1. Range checking performed prior to execution of the FIST[P] instruction will prevent the overflow condition from occurring, and may already be implemented as a coding style.
2. Software can use the presence of MAXNEG in the result integer to indicate that an out of range conversion may have occurred.

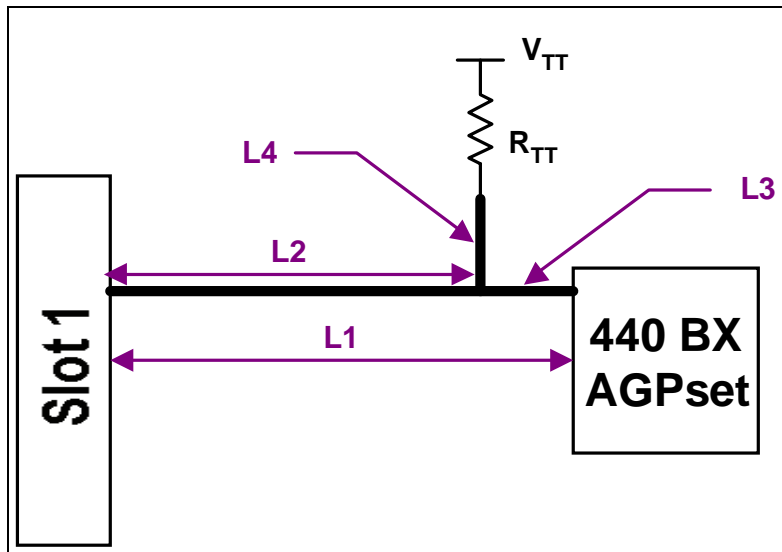
Figure 1. UP Dual Ended Termination (DET)

IMPLICATION: This violation of the bus exchange protocol when using a reduced arbitration latency may cause a system-level setup timing violation on the address, address parity, request command, or request parity signals on the system bus. This may result in a system hang or assertion of the AERR# signal, causing an attempted corrective action or shutdown of the system, as the system hardware and software dictate. The possibility of failure due to the contention caused by this erratum may be increased due to the processor's internal active pull-up of these signals on the clock after the signals are no longer being driven by the processor.

WORKAROUND: If the chipset and third party agents used with the Pentium II processor do not optimize their arbitration latency as described above, no action is required. For the 66 MHz Pentium II processor, no action is required. If agents that have implemented this optimization, by following the *100 MHz GTL+ Layout Guidelines for the Pentium® II Processor* and *Intel 440BX AGPset* for UP-SET (single-ended termination) and DP with both processors installed, no action is required. The following two cases are additional guidelines for UP-DET (dual-ended termination) and DP-DET with only one processor populated.

For UP-DET topologies (see Figure 1), the trace length L1 must be between 1.5" to 4.5" while using a 56Ω termination resistor.
